# Railroad accident investigation report

Report No. 79-9

LOUISVILLE AND NASHVILLE RAILROAD COMPANY

CRESTVIEW, FLORIDA

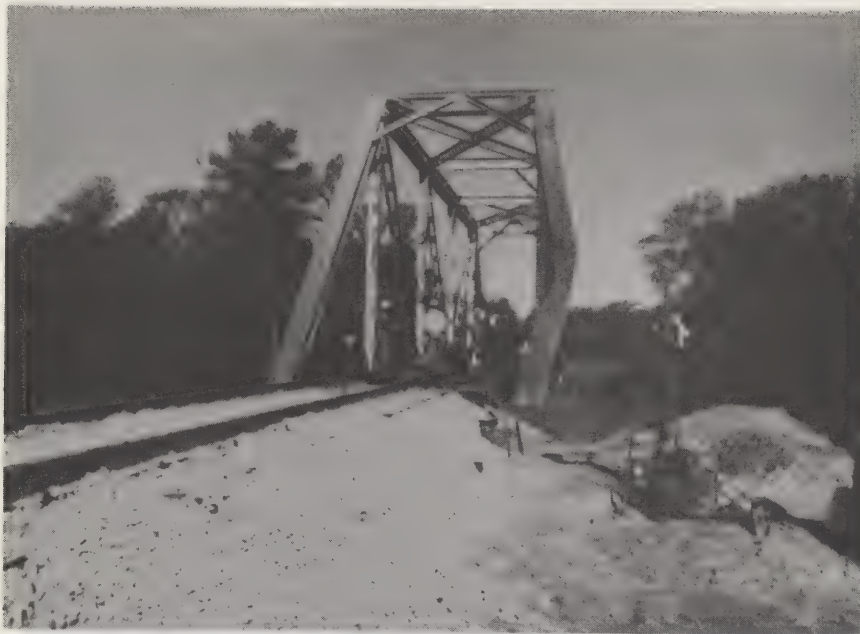
Post-accident examination of the bridge structure revealed that the 72-foot, pile-driven trestle was completely destroyed by the derailment and resulting fire. The thru-truss span sustained substantial damage to the southeast hip hanger, south end stringers of panel five, east bottom chord of panel five and south end floor beam. Heat damage was also sustained to various other bridge members. The 125-foot track structure on the thru-truss span of the bridge received extensive heat damage from the burning cars. About 80 percent of the ties and 70 percent of the rail were destroyed on the truss. Samples of the web of the south ends of both stringers, the bottom flange angles, and a rivet from the west stringer were tested by an independent laboratory. The results indicate that the fire did not alter the metallurgical or mechanical properties of the samples tested.

**Damage to west portal member of Yellow River bridge.**

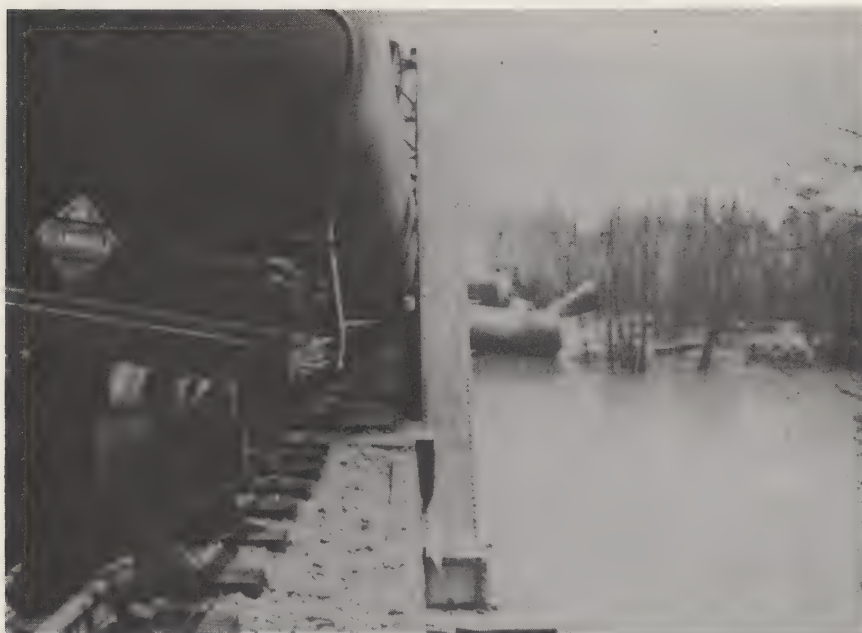
**View of derailment site from east portal member of bridge**

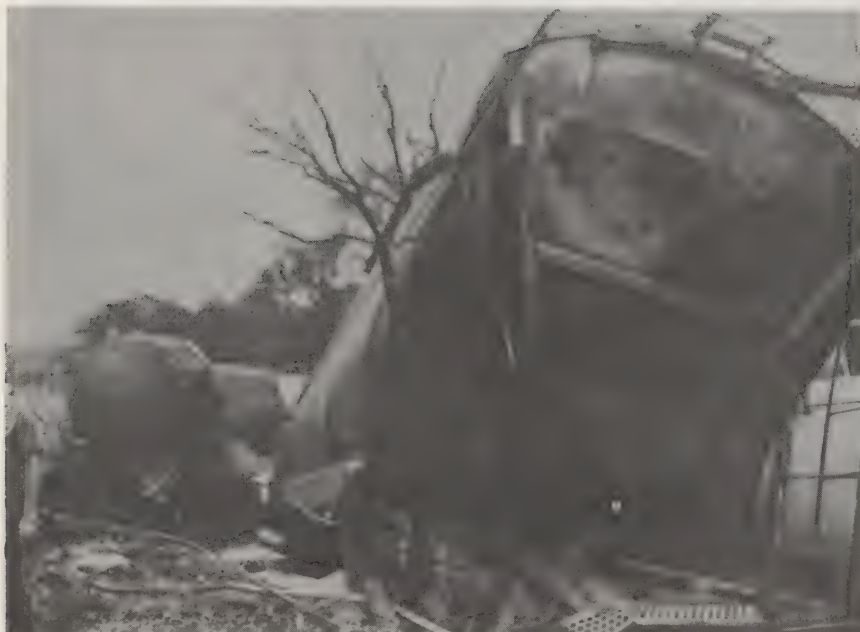
**View of damaged equipment.**

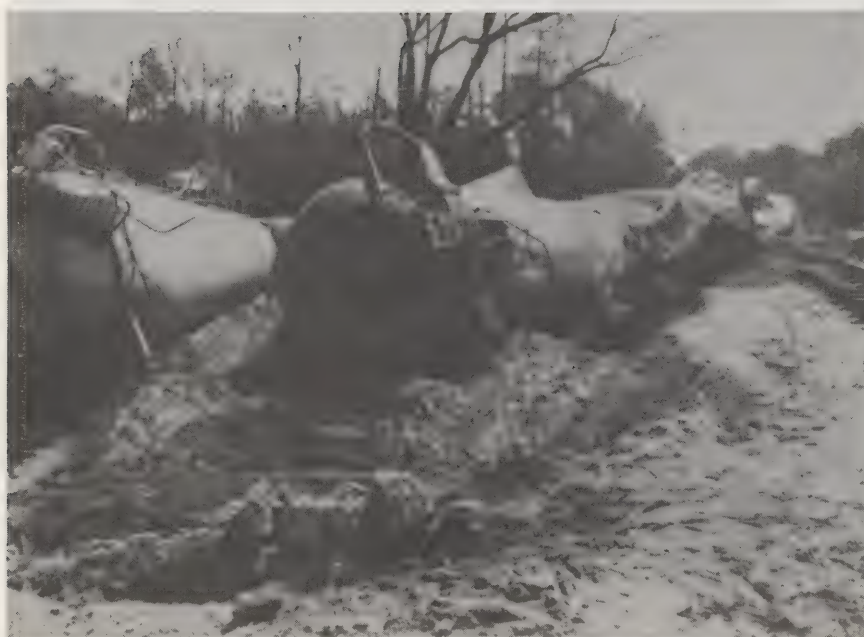
**View of damaged tank cars.**

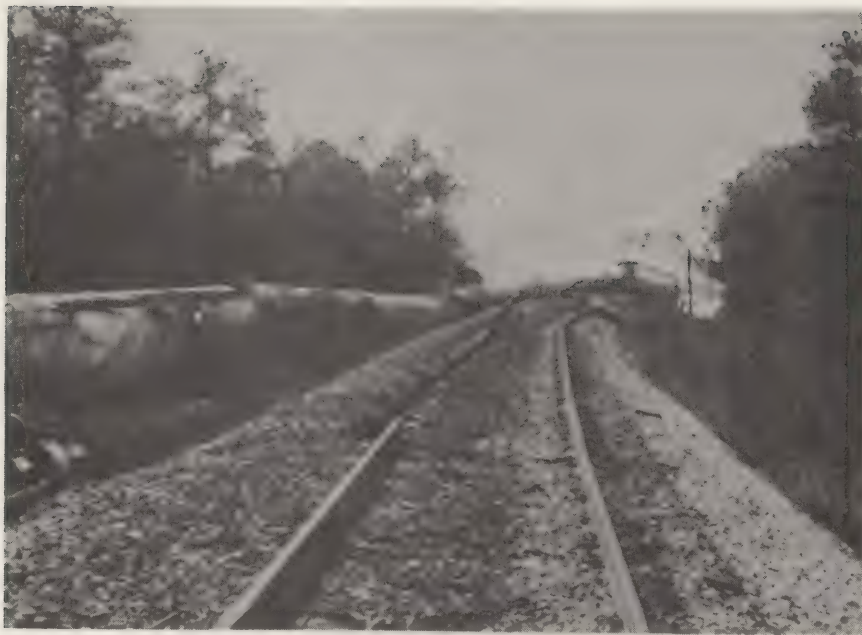
The carrier recovered all except 25 feet of the west rail from the accident area. All rail recovered from the wreck site was examined. This examination revealed only stress breaks and no signs of internal defects. Marks on the rail did not indicate where the initial derailment had occurred. Although 25 feet of the west rail, which was the low or stress rail in the accident area, was never recovered, examination of the cars which passed the derailment site did not reveal any of the markings which are usually associated with the presence of a broken rail.

**Track structure after derailment.**

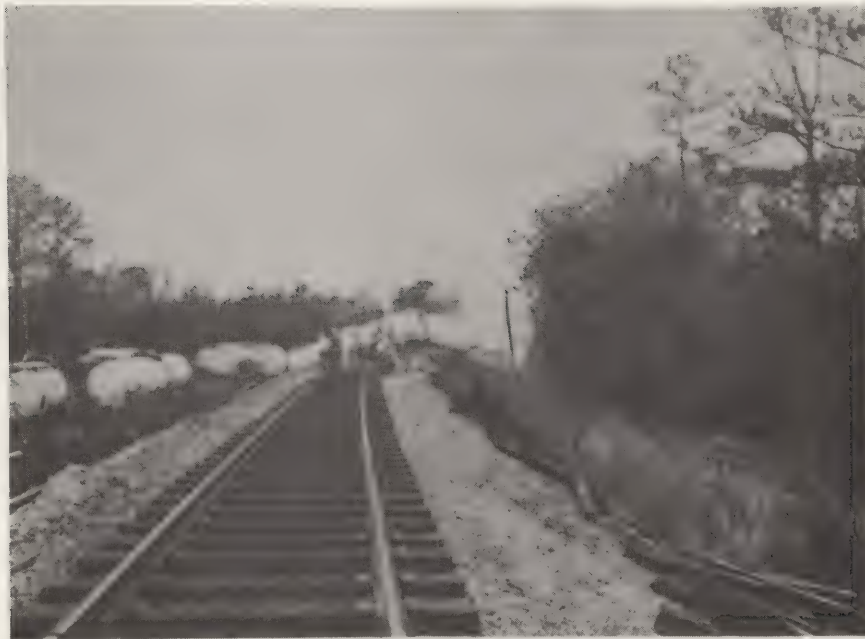
**Track structure being restored.**

The wreck was cleared, the track and bridge were temporarily repaired, and train operations were resumed on April 14, 1979. At that time, L&N issued additional operating instructions on the line between Pensacola and Chattahoochee, Florida. Southward trains were restricted to a maximum of 120 cars and 8,000 tons. A speed restriction of 5 mph, later increased to 10 mph, was placed in effect in the area of the derailment until permanent bridge repairs could be made. Supervisors were assigned to ride all road trains on this sub-division for a period after the track was reopened.
